# Johnsburg, IL

## Pavement Management Report

August 2022

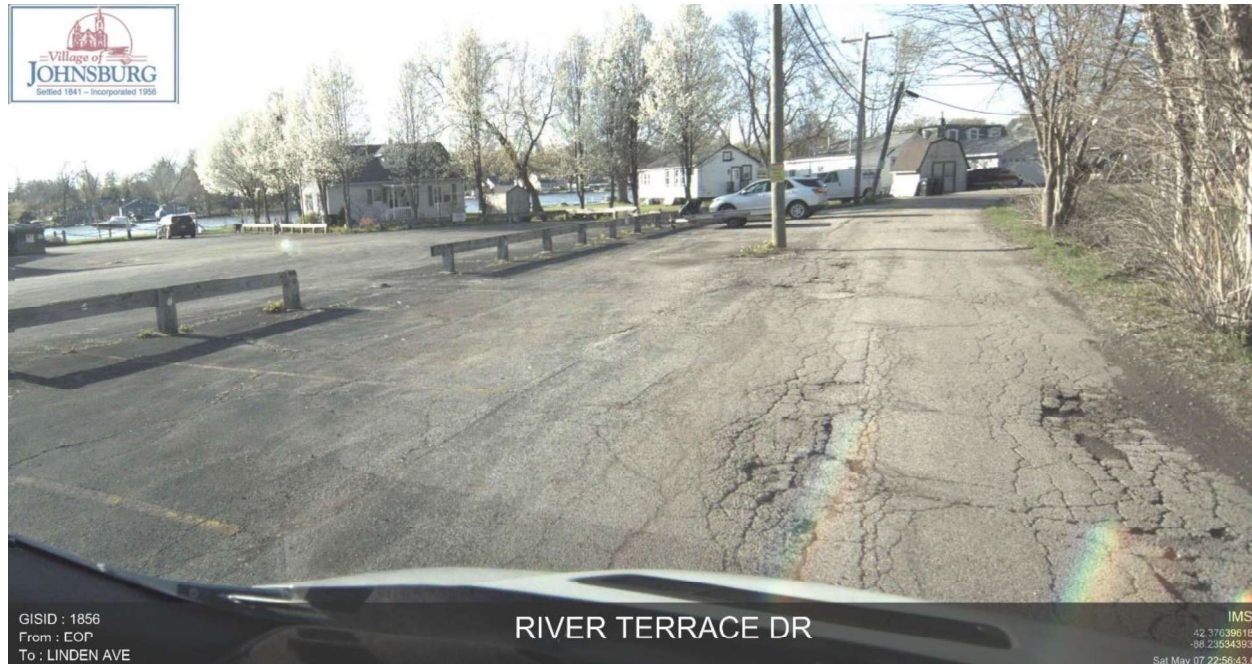
**Figure 8 – Example of a Pavement Rated as Failed**

**River Terrace Drive from End-of-pavement to Linden Avenue (GISID 1856, PCI = 6)** – As the only segment in the network rated as Failed at the time of the survey, this pavement displays spreading base failure as evidenced by the severe alligator cracking and potholes. A mill and overlay on this street would not be suitable and would not meet an extended service life of at least 15 years. This street requires a full reconstruction.

Deferral of reconstruction of pavements rated as Failed will not cause a substantial decrease in overall pavement quality. The pavements have passed the opportunity for overlay-based strategies, meaning that reconstruction, which is expensive, is the most suitable solution. Failed pavements are often deferred in favor of rehabilitating more segments at lower costs, resulting in a greater net benefit to the Village. This strategy however must be sensitive to citizen complaints forcing the street to be selected earlier. In addition, this type of street can pose a safety hazard for motorists since severe potholes and distortions may develop. It is important to consistently monitor these pavements and check for potholes or other structural deficiencies until the street is eventually rebuilt.

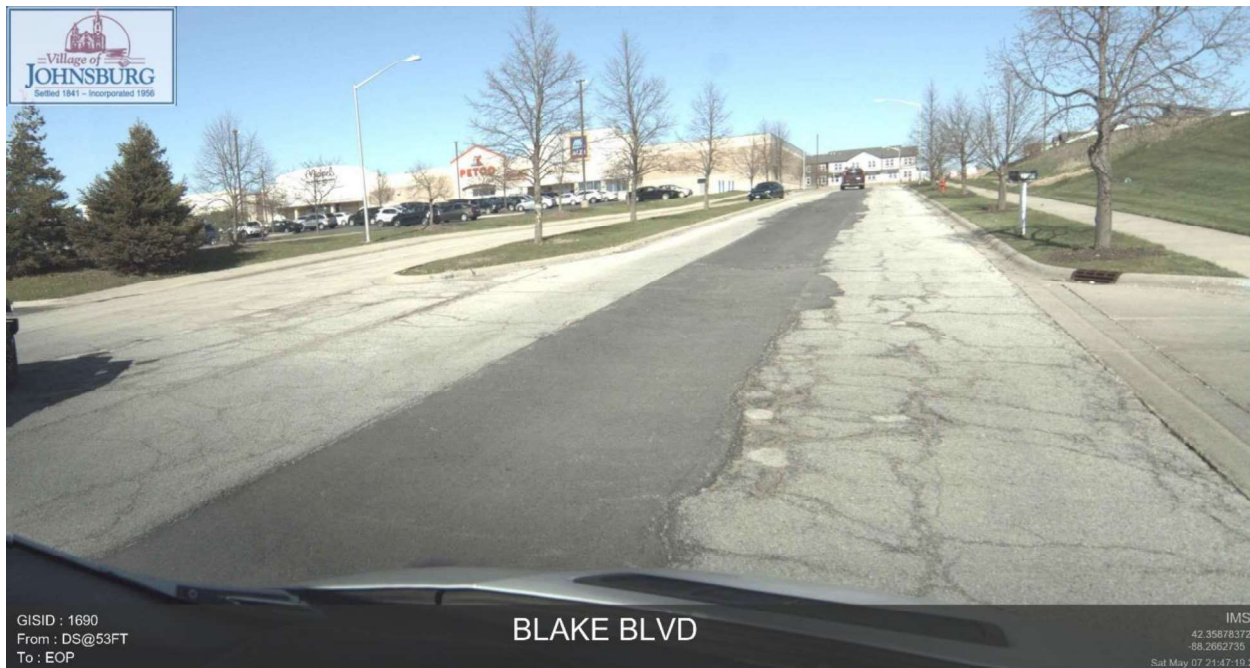
**Figure 9 - Example of a Pavement Rated as Serious**

**Blake Boulevard from DS53FT to End-of-Pavement (GISID 1690, PCI = 15)** – Rated as Serious, this segment is rapidly approaching the end of its service life. As evident in the imagery, a fair amount of alligator cracking and potholes contribute to the lower PCI score of this segment. If left untreated, within a short period of time, a full reconstruction would be required.

Heavily trafficked pavements in serious condition often require a full reconstruction. On local pavements, partial reconstruction is typically required, that is the removal of the pavement surface through grinding or excavation, base repairs, restoration of the curb line and drainage, and then placement of a new surface.

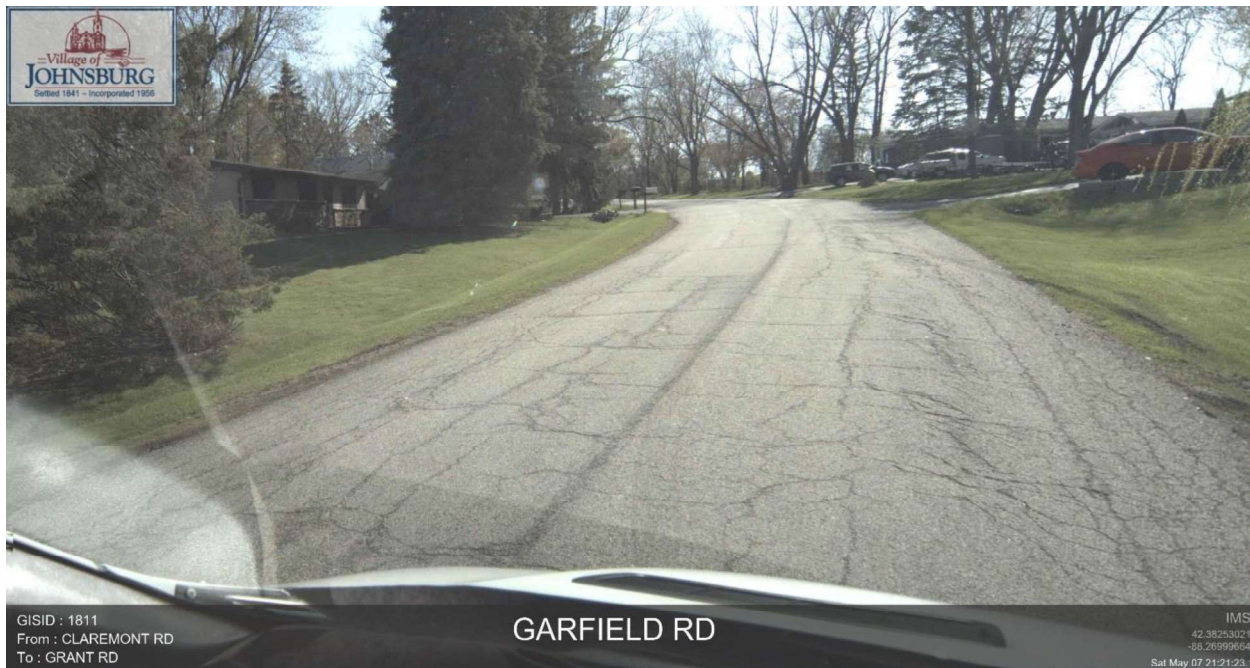
**Figure 10 - Example of a Pavement Rated as Very Poor**

**Garfield Road from Claremont Road to Grant Road (GISID 1811, PCI = 30)** – On this segment, the evidence of deterioration is the alligator and edge cracking, which can be clearly seen in the image above.

Very Poor pavements that display high amounts of load associated distresses are selected as a priority for rehabilitation, as they provide the greatest cost/benefit to the Village. If left untreated, Very Poor pavements with high amounts of load associated distresses would deteriorate to become partial reconstruction candidates. Very Poor pavements that are failing due to materials issues or non-load associated failures may become suitable candidates for thick overlays, if deferred, without a significant cost increase.

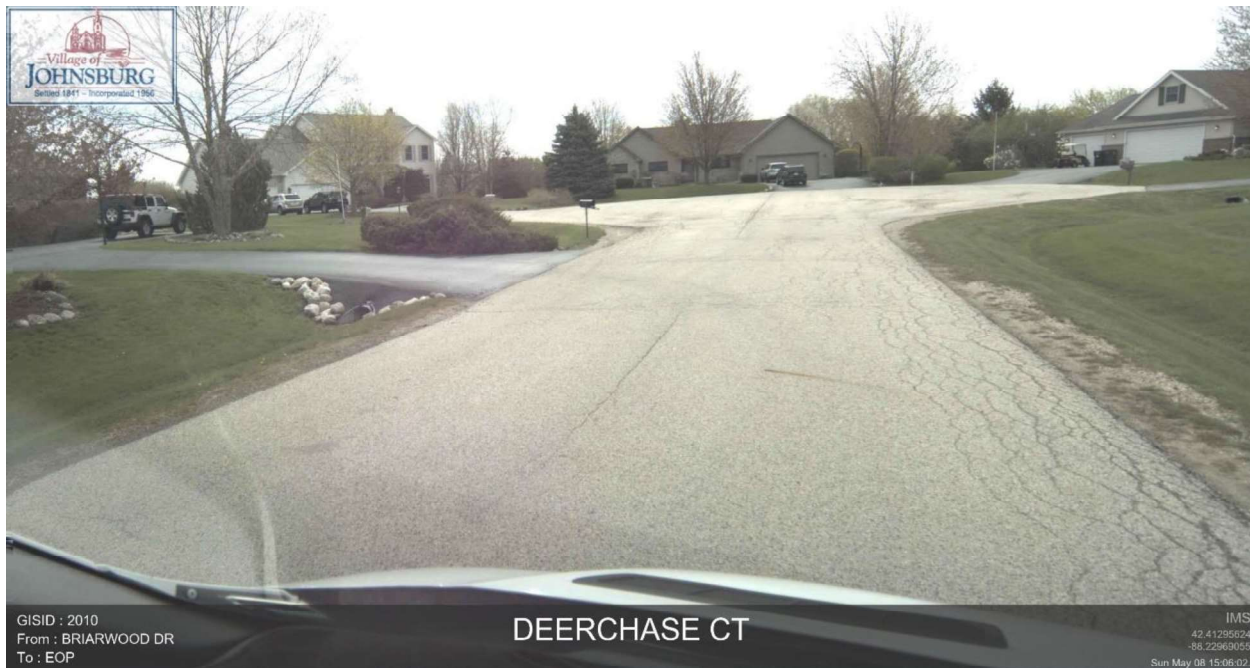
**Figure 11 - Example of a Pavement (roadway) Rated as Poor**

**Deerchase Court from Briarwood Drive to End-of-Pavement (GISID 2010, PCI = 47)** – Several distresses are present, but tend to be more localized and moderate in severity (primarily edge cracking). The existing edge cracking is only present on the right-hand side of this road. (as seen in the image above)

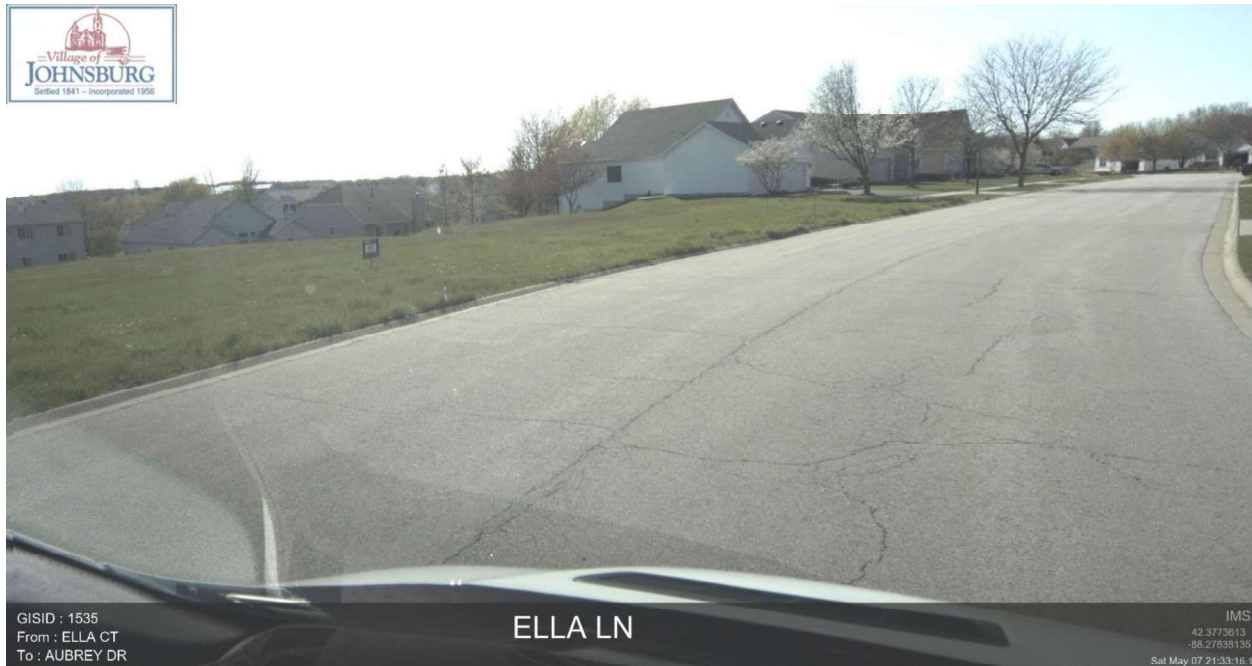
**Figure 12 - Example of a Pavement Rated as Fair**

**Ella Lane from Ella Court to Aubrey Drive (GISID 1535, PCI = 64)** – Rated as Fair with the transverse and longitudinal cracking as the primary cause of deterioration. The existing distresses could be sealed, and the pavement surface restored further with a heavier surface treatment, such as microsurfacing, to fully waterproof the pavement and cover the localized edge patches.

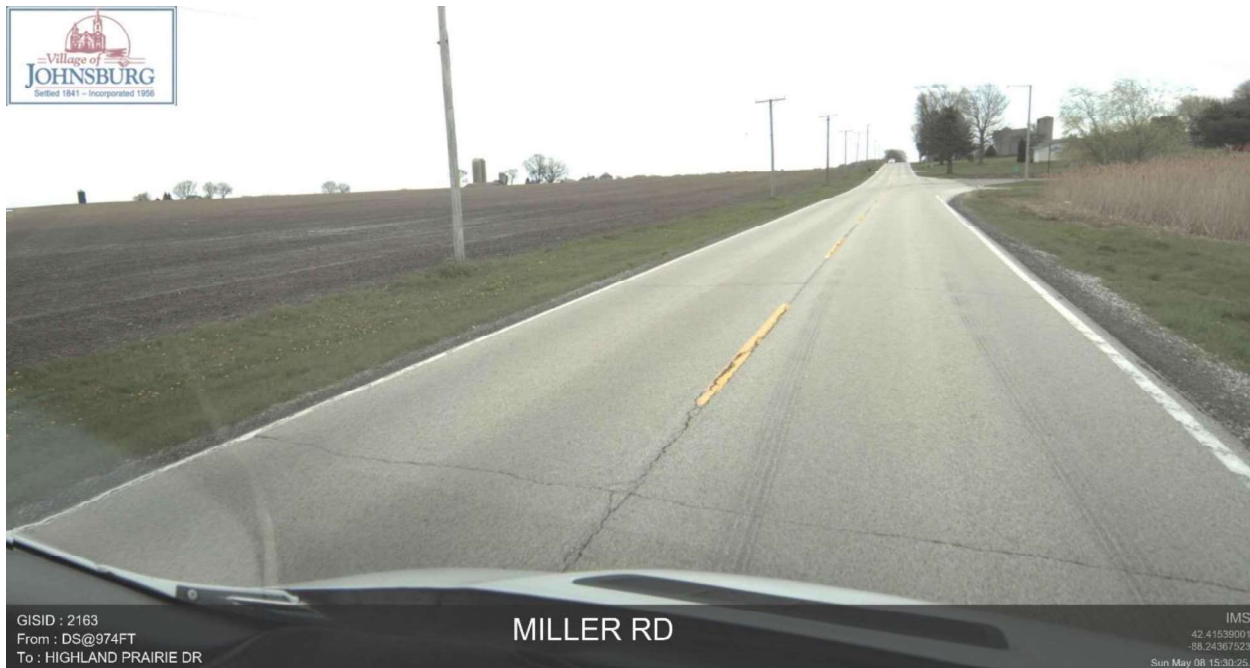
**Figure 13 - Example of a Pavement Rated as Satisfactory**

**Miller Road from DS974Ft to Highland Prairie Drive (GISID 2163, PCI = 72)** – Rated as Satisfactory, this road displays minor amounts of transverse cracking. This street is an example of a candidate for preventative maintenance, such as crack sealing, to extend its service life.

Routine maintenance, such as crack sealing and localized patching, allows the cracks to be as waterproof as possible. By keeping water out of the base layers, the pavement life is extended without the need for heavier rehabilitation.

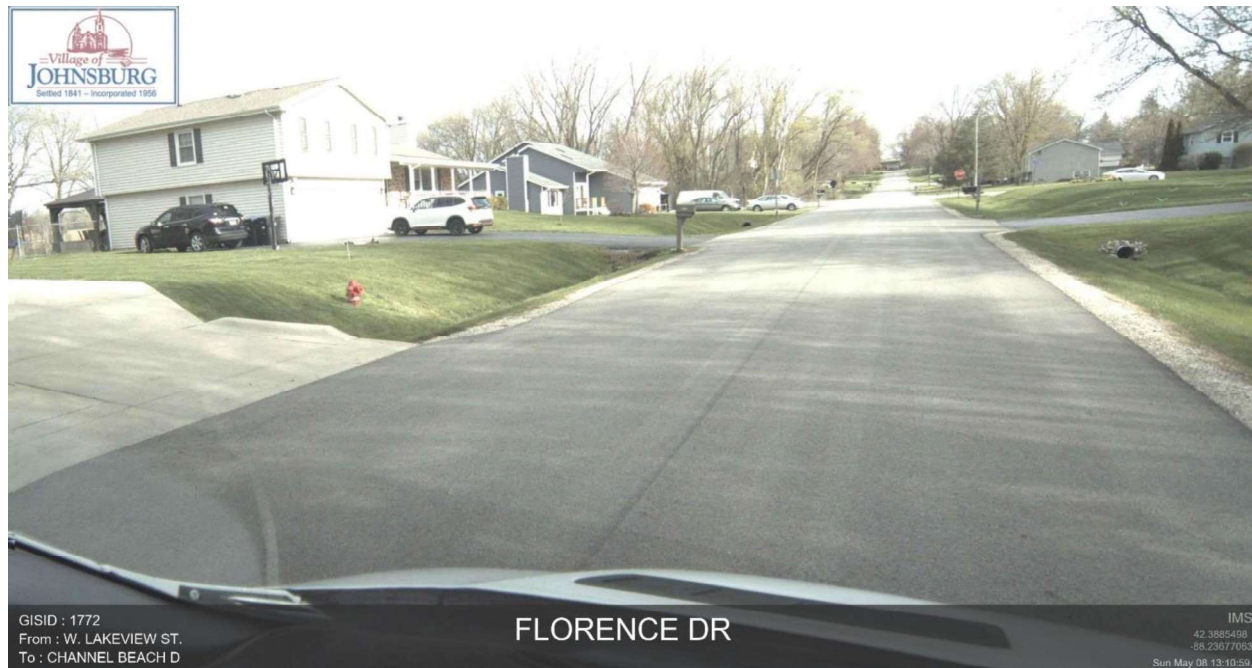
**Figure 14 - Example of a Pavement Rated as Good**

**Florence Drive from West Lakeview Street to Channel Beach Drive (GISID 1772, PCI = 95)** – Rated as Good, displaying little to no surface distresses. The ride quality is smooth, and the surface and base are intact.
